Troubleshooting 2-Part Molds

2 Common Pitfalls to Avoid

By Bob Cottrell, CPIM

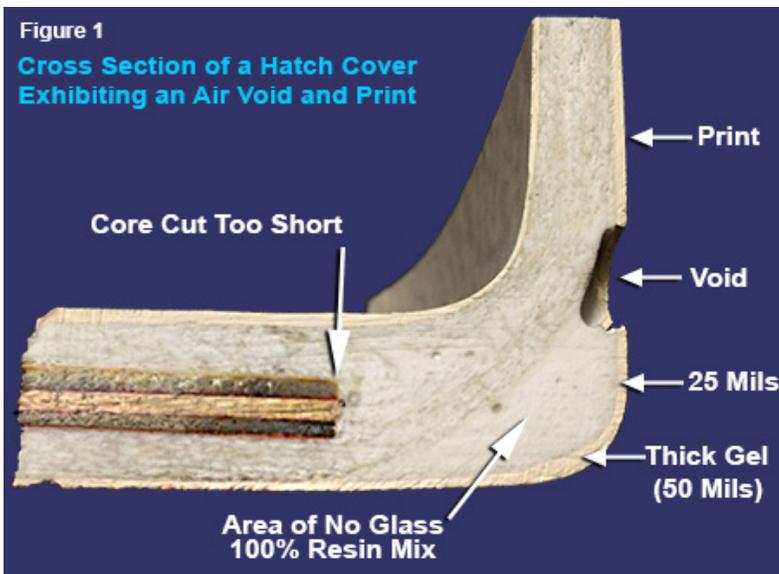
These may seem like obvious points, but the cross section shown in Figure 1 illustrates just how straying from these principles causes defects – in this case air voids and print.

Note first that the core stops far short of the vertical return of the hatch. This allows the fiberglass (the darker portions of Figure 1) under the core to take a “shortcut” and creates a space in the corner where resin (or resin mix) pools. This is a problem for a couple of reasons. First it leaves a large unreinforced area behind the gel coat in a particularly vulnerable (to potential blows) area. But, also, the large pool shrinks more than the surrounding glass/resin matrix, creating stresses that pull on the gel coat and create print.

Notice that the air void is located at the top of resin pool under the fiberglass. With a proper fitting core, this air bubble would have had no place to “hide” and would have been flushed out.

The other contributing factor to the print which this part exhibits is the uneven gel coat thickness. As seen in Figure 1, the gel coat is 50 mils thick in the corner and half that thickness on the nearby sidewall. This magnitude of variation – particularly in the corner of a female mold – is a well accepted recipe for prerelease and print of the gel coat.

How far should the core extend? Ideally, it should be cut so as to fit halfway into the laminate thickness of the vertical return. If this were the case in Figure 1, the glass under the core would be forced into the corner eliminating the pool and reinforcing the gel coat.

The main cause of excessive variability in gel coat thickness in smaller parts is too high of an application rate. The material is exiting the spray gun faster than the operator can deal with it. A smaller tip, reduced pump pressure and additional operator training may be in order. While maintaining a gel coat thickness tolerance on small parts of 18 to 20 mils is probably a dream, 15 to 25 mils should be possible and should resolve most associated problems.
